Vs

The Speedway 9-super-7

We first heard rumours of a new 97 copy from Speedway Motors around a year ago. And now it's here. The Speedway Motors 9-super-7 carburetor. But was it worth the wait?

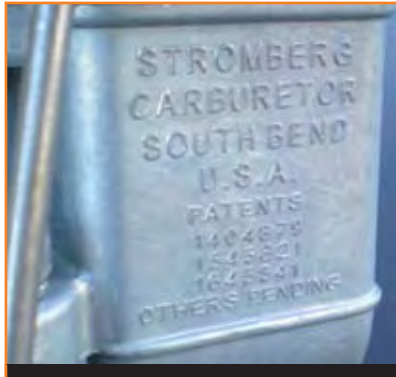
There is no Stromberg name or patent markings.

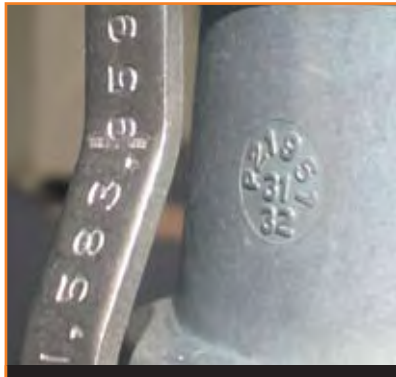
There are no casting ID numbers or venturi size markings.

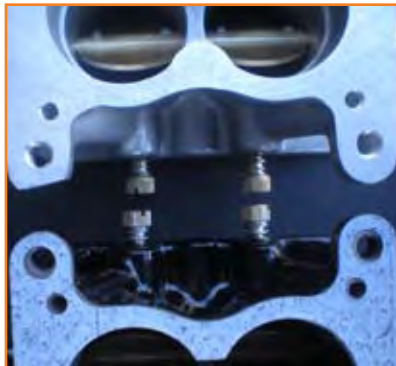
The front screw mounting boss on the top flange has been ground off (!) maybe because it fouled on the bowl section. This is because the whole casting is oversize. It is at least 0.1 inch bigger in both overall dimensions.

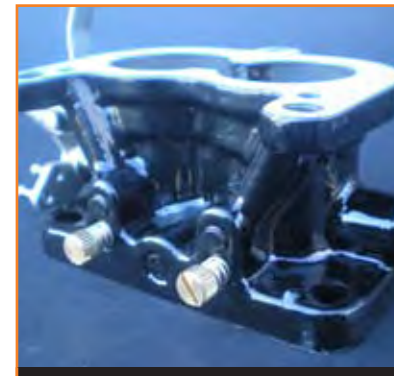
The front plugs in the base are not correct. They should be small removable plugs. These are ball bearings.

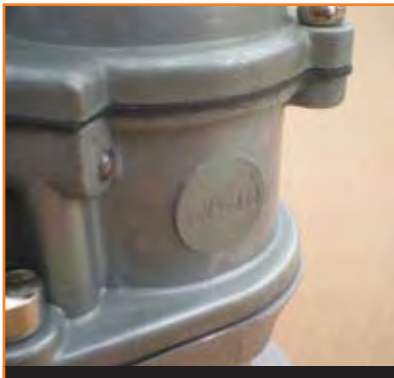
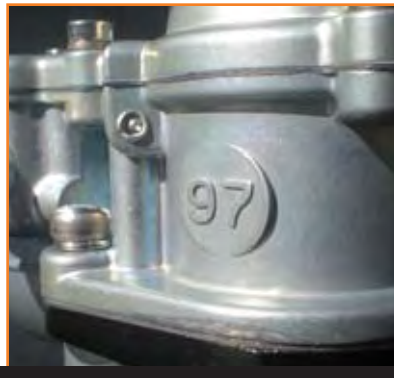
There is no big 97 marking. The non-genuine SP-10 mark looks like it has been hand engraved into the casting.

The throttle shaft is oversize at 0.281 instead of the correct 0.276inch which means less air flow at higher rpm. There is excessive end play in the throttle shaft, which shouldn't exist once the throttle plates are installed. The shaft also has excessive side play in the bush and you can see the clearance in the casting centre web. The whole throttle shaft bore should be reamed to a closer tolerance.

The kicker bush (which holds the throttle shaft at the linkage end) is 0.3inch ID, and the plain bush at the other end is around 0.288inch ID, meaning around 0.007 to 0.019inch clearance on the 0.281inch shaft. The original Ford wear limit is just 0.005inch so both are over limit. You can see daylight along the gaps. This could give the carburetor air leak issues with uneven idle.

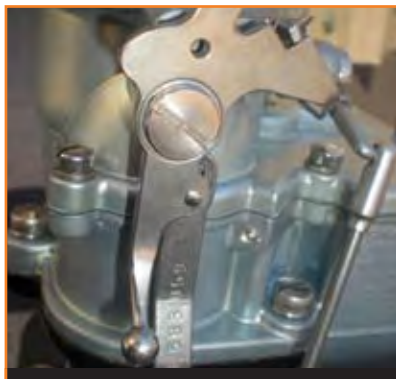
The choke lever should have a countersink mark around the fulcrum screw (see left). It's missing. The choke lever return spring is wrong, too.

The kicker piece should be neatly riveted to the choke lever and the rivet should

have a shoulder so the two parts remain free on riveting. On this example, the choke lever does not move freely on the kicker. There is only one washer on that rivet where there should be two – a plain and a wave washer.

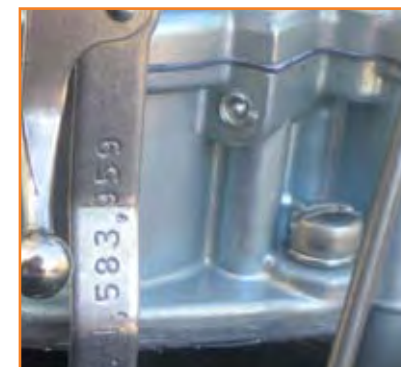
The Speedway choke shaft end lever is not stainless steel and it is fixed with a screw. It should be riveted like the original Stromberg part (see right). The choke return spring was pulled out of shape.

The choke lever detent pin is plated steel, not stainless steel. The spring (hidden under the pin) was fixed on the wrong way around.

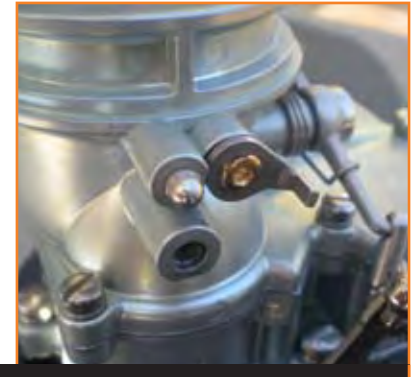
The Speedway accelerator pump rod (top) has an incorrect look with squared off end caps and a strange end swage.

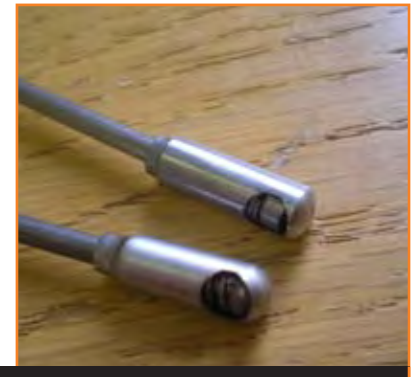
The accelerator pump lever return spring is too strong. And when the accelerator pump rod is on the S (shorter) ball adjustment, the throttle snaps to over-centre and does not release, which could be highly dangerous in use.

The throttle linkage end piece is a poor facsimile of the original part. The Genuine Stromberg piece is an accurate investment casting. This is a folded steel piece. It is difficult to tell whether the S and W balls are in the correct position to operate the accelerator pump correctly.

The Speedway end piece is screwed on with a socket head screw instead of riveted like the Genuine Stromberg part.

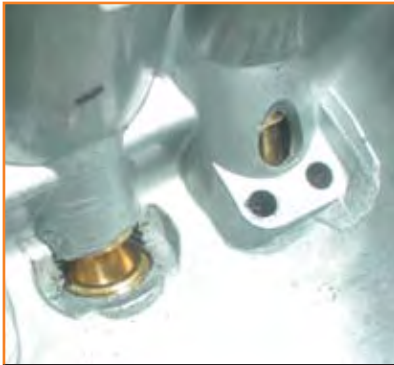
The casting finish is fractured inside the Speedway float bowl and there is evidence of poor die repairs (see left).

The Speedway carburetor has a plastic float - which was not adjusted correctly from the factory, so this carburetor might not run straight out of the box. Genuine Stromberg carburetors use a brass float, made in the USA on the original Stromberg dies.

The Speedway float lever is not vertical on the centre of the hinge pin so sits too far forward onto the inlet valve.

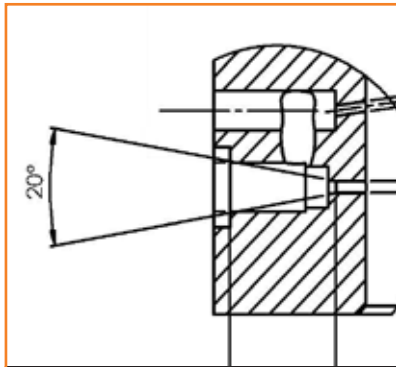
The lower idle holes should have a 20 deg angle in the bottom to match the angle on the idle adjustment screws. This is not in place.

The throttle plate screws are not correct. They should be brass countersunk slotted. These are lightweight aluminium cross-heads with a very fine thread. And they don't have the hollow ends

so you cannot stake the ends to prevent them falling out. These examples look like they were sealed in with a liquid sealant. All this makes future service very difficult indeed.

The throttle plates are oversize. The original Stromberg specification is 1.855inch + 0 and - 0.002. These are 1.203inch so they do not sit correctly in the throttle bore.

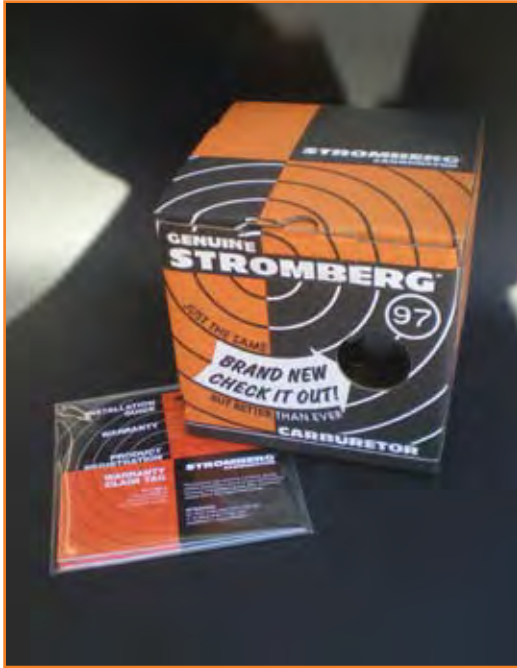
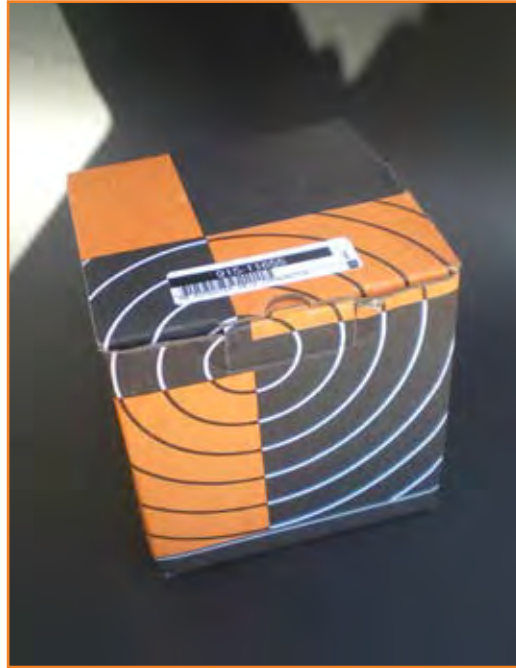
Packaging

The outer box looks like an attempt to pass this carburetor off as the Genuine Stromberg part, which it is clearly not.

There were no installation instructions. No warranty details. No owner registration form. This brings the question, are users protected in the event of a problem? Is there any warranty on the part? And if so, what are the terms?

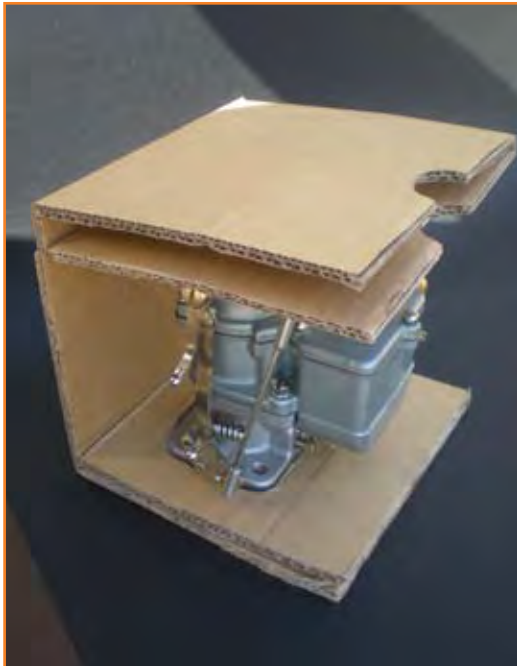
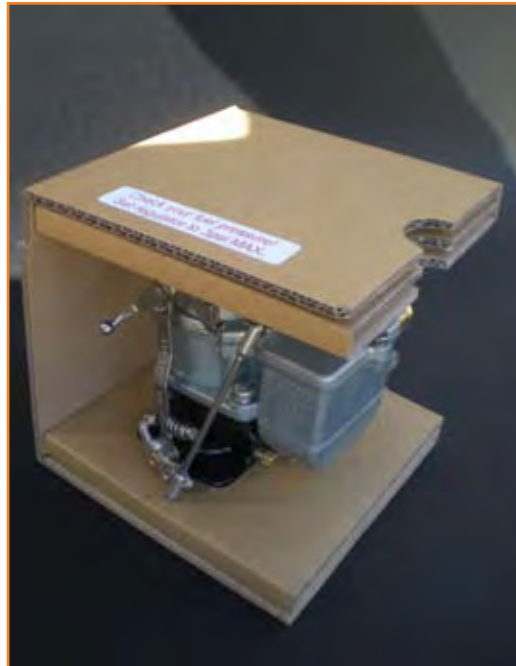
The box insert has just one layer of card to hold the carburetor in place top and bottom during shipping. In our experience, this is not enough and has the potential for the carburetor to break loose in shipping (as this one did). Genuine Strombergs have a more secure double thickness pocket, top and bottom.
