ANTIQUE SHOCKS NEED A MODERN REBUILD

by Brian Brennan

Lever action shocks are very common on early and classic cars, but just try to purchase new ones at the local auto parts store!

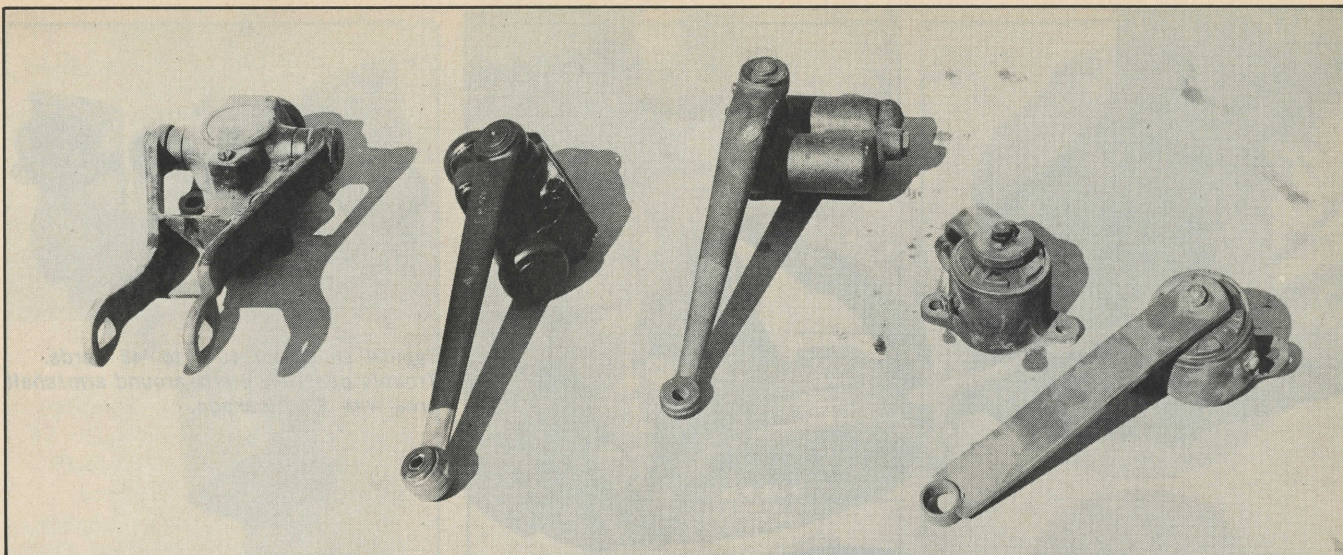
Examples of lever action shocks Paul is consistently rebuilding. Left to right: Cadillac front and rear, Buick, and a pair for Studebaker.

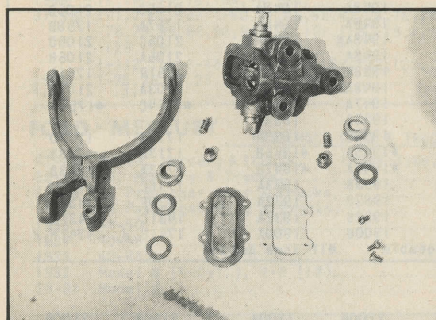
Early Chevy shock for front has two different check valves, each must be fitted into proper position. When going bad, these shocks leak through gland and packing.

To rebuild a knee action shock, a number of steps must be closely followed. The gland and packing are made up of a metal cap, cork and rubber gasket. This part is designed to keep the shock fluid from escaping around the splined shaft and should always be replaced once removed. Even if the gland and packing were good on the old shock, once it has been removed the seal is broken and cannot be resealed to prevent leakage. The check valve is the heart of an old shock. This valve is designed to regulate the pressure within the shock itself. The check valve can be modified to give 50/50, 70/30 or 60/40 action, regulating the type of ride desired. Since this particular part is becoming very scarce, it is best to rebuild the old check valve if possible.

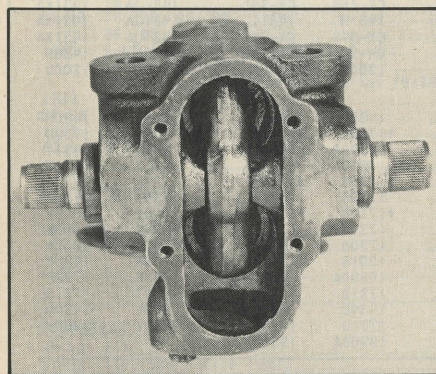
Rocker is activated by upper control arm on Chevrolet double-action piston type. When removing arms from shock, be careful not to damage splines.

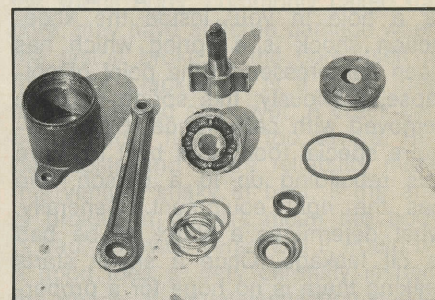
Example of a Ford Model A and B shock. Make sure to check arm and mounting "ears" for cracks, as this will have to be solved by welding or replacement.

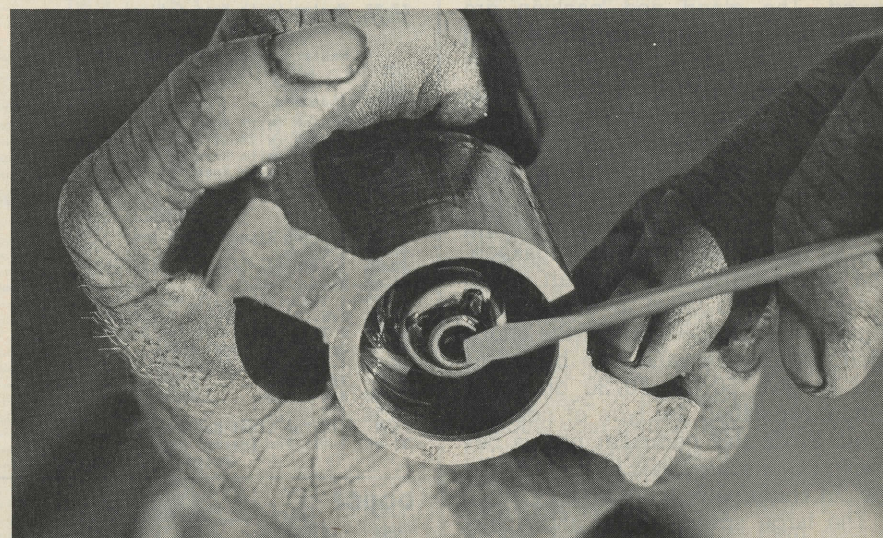
Internal workings of Ford Model A and B shocks after modifications by Paul Kagel. Check spring for any cracks or obvious breaks; replace if cracked or broken.

The large spring, if the shock has one, generally doesn't go bad, but they have been known to break and if this is the case it must be replaced. Next

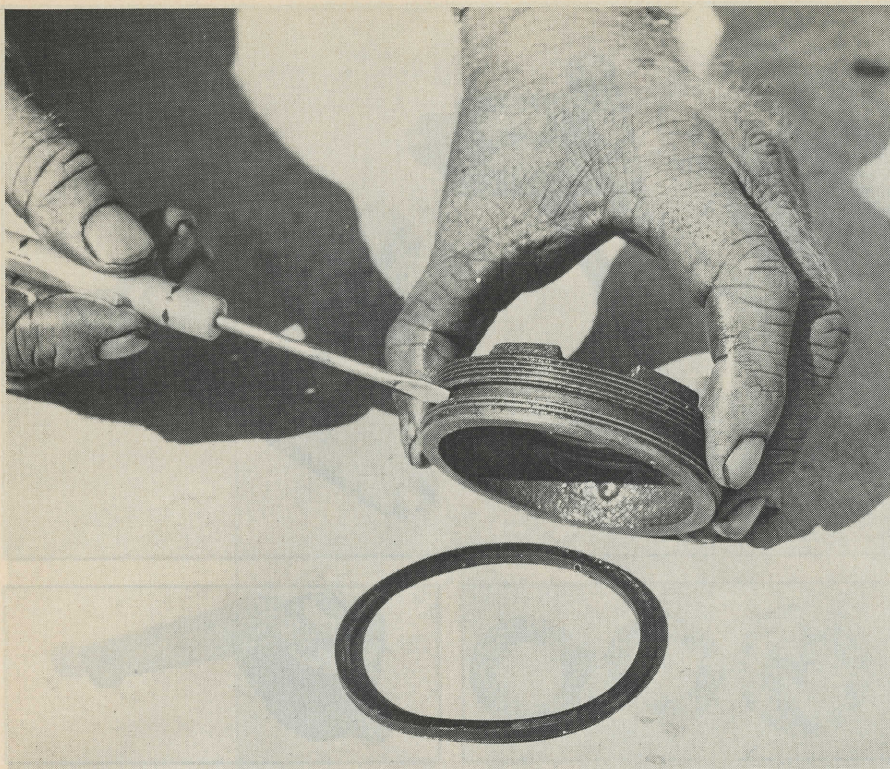
Check valve is inside vane on Ford A and B shocks. Held in place by snap ring, valve can be adjusted for ride control. These valves are scarce.

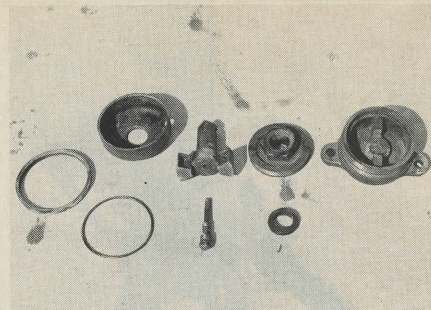
Typical shock for 1941 to '48 Fords.
Trouble generally starts around arm/shaft
area with fluid leakage.

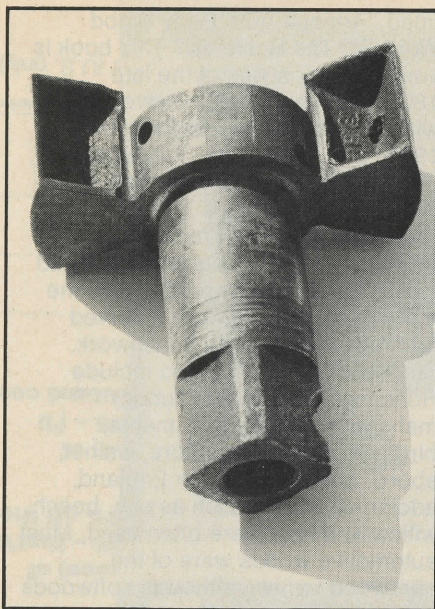
As modified by Paul, cap for 1928 to '32
Ford shocks shows grooved area and
then O-ring. This prevents leakage of
shock fluid past threads after
prolonged usage. Can be done at
home on a shop lathe.

There are other possible modifications, such as machining a groove around the core cap and installing a large rubber O-ring. The intent is to increase the life of the shock; there's less chance of leakage through the threaded area of the cap.

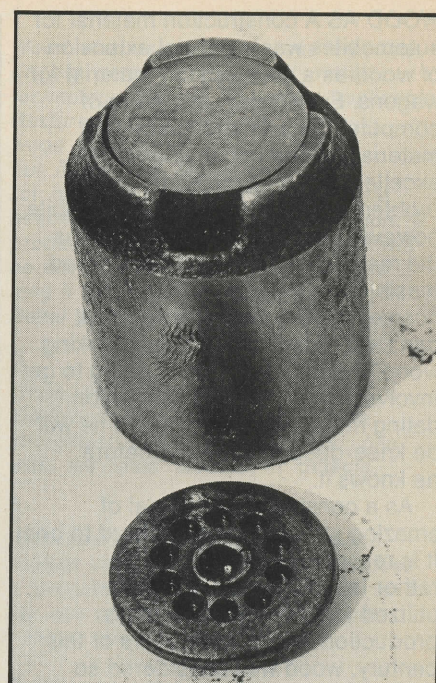
Piston assembly from early Chevy shock. If there is piston damage, bore of shock core could be bad, causing more trouble.

comes the shock piston. If this is damaged or broken, the internal wall of the shock body, commonly called the core, may have suffered damage when the piston broke. If the core itself is rough or cracked, it is a good idea to scrap it and start over. A crack can be welded if it is not too severe. Repair costs and future reliability make this venture shaky at best. If the arm is broken, it doesn't mean the body is bad, and vice versa, but it would be a good idea to very carefully inspect the shock. If visual inspection shows any parts to be defective, check closely the rest as the damage may be wider spread. On shocks from a Ford Model A or B, an internal vane is used instead of the piston as on other shocks. If it is damaged, the entire shock is history!
