Vs

The Speedway 9-super-7

We first heard rumours of a new 97 copy from Speedway Motors around a year ago. And now it's here. The Speedway Motors 9-super-7 carburetor. But was it worth the wait?

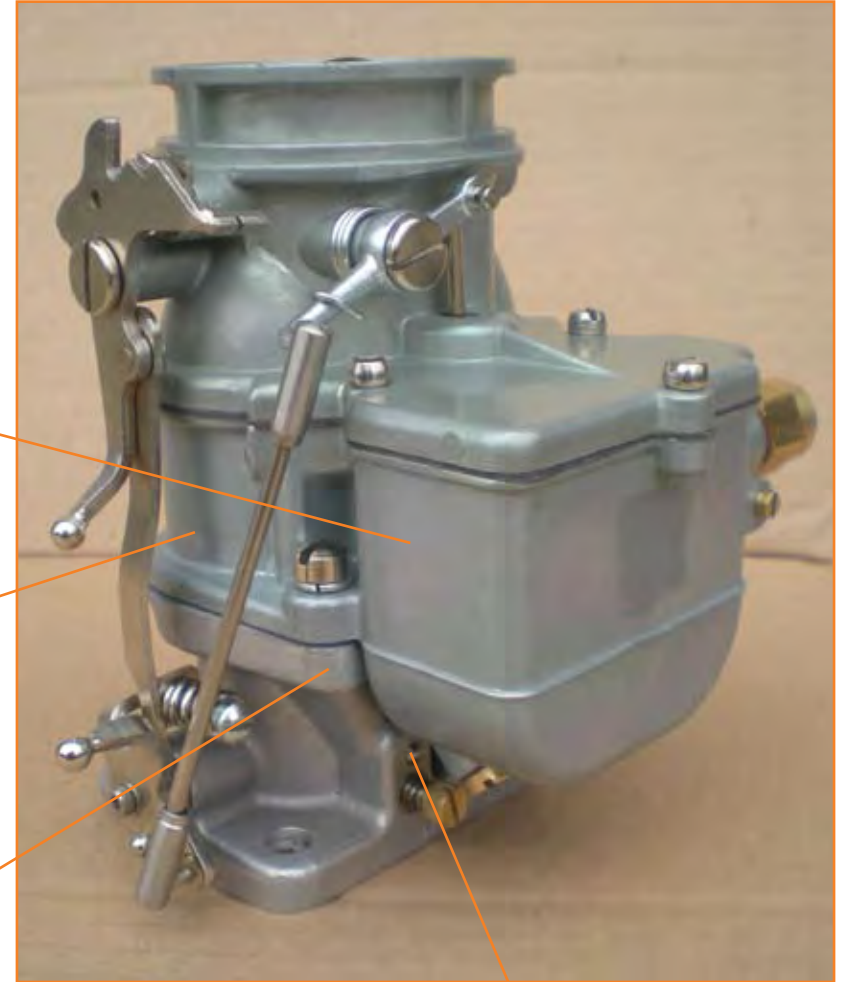
The front plugs in the base are not correct. They should be small removable plugs. These are ball bearings.

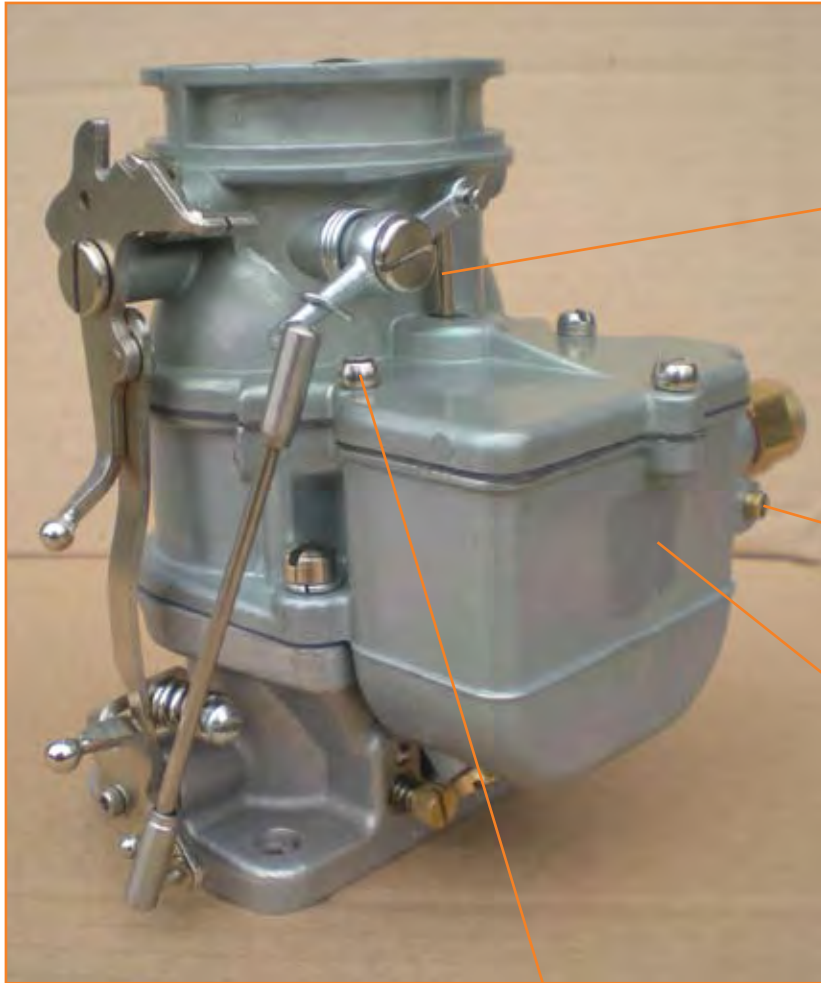
The Speedway accelerator pump top rod and spring retainer are not stainless steel like Genuine Stromberg. The spring retainer is oversize in the centre slot so it catches in the spring and leans out of alignment, which could cause it to catch in the accelerator pump well.

The spring inside the accelerator pump leather is not correct (under size) and has little effect on retaining the leather shape in use. The irregular leather, and the extra thin felt washer are both under spec.

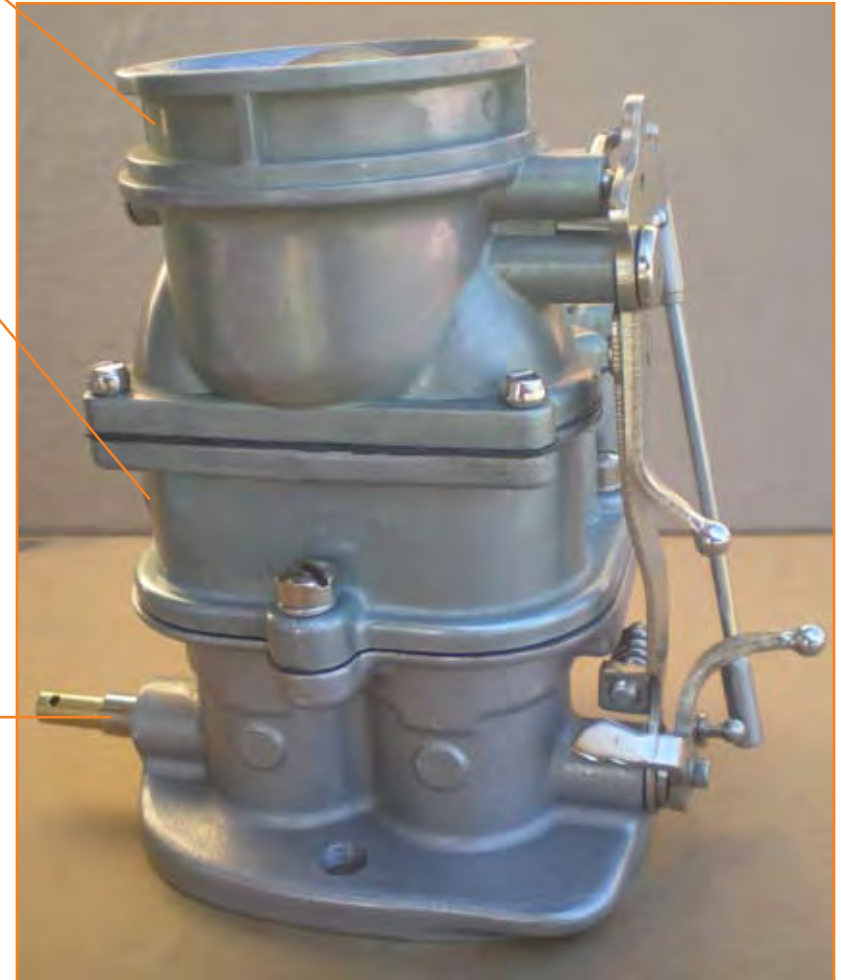
The Speedway base casting is made of aluminium instead of the correct cast iron. This is not only non-original, but aluminium is one of the most thermally conductive materials in the world, making ice formation a real possibility. In our opinion it may also wear too quickly in use, with the potential for poor idle control.

It is painted silver and should be black.

The machined height of the base casting is about 0.025 inch too tall, which will affect the power valve accuation point. The correct Stromberg tolerance is 0.005inch. Also the flange thicknesses are incorrectly shaped at the

top - too thick at the front and almost non-existent at the back.

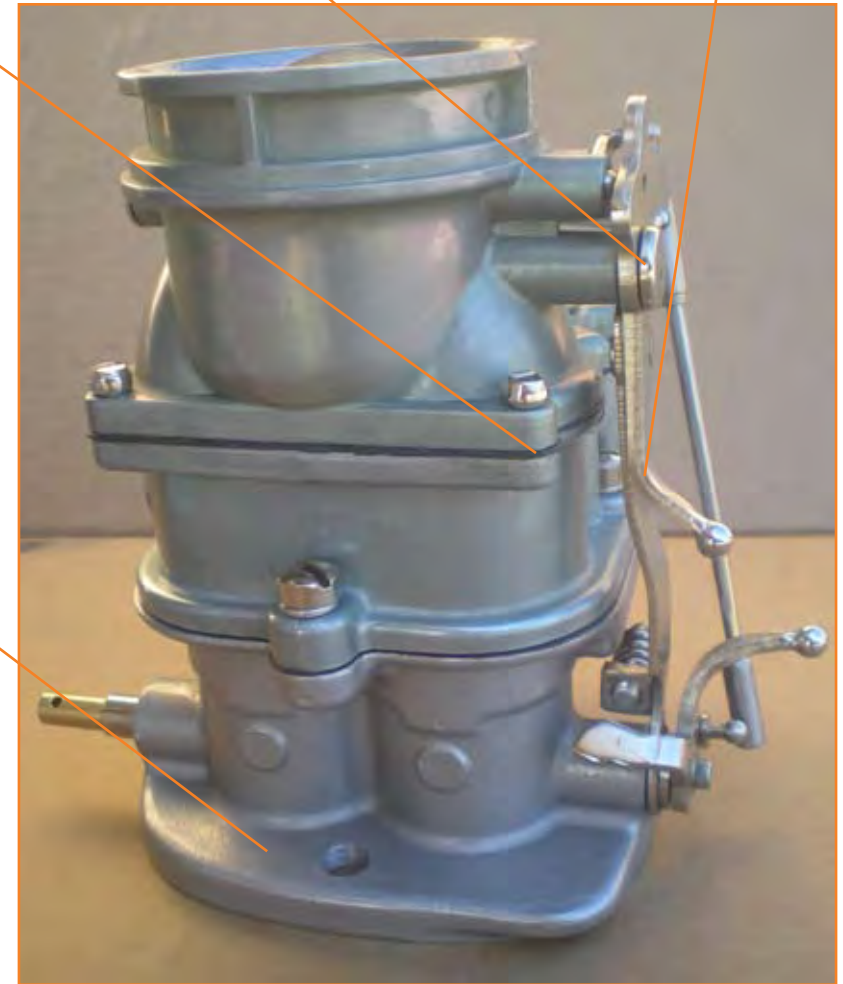
The choke lever should have a countersink mark around the fulcrum screw (see left). It's missing. The choke lever return spring is wrong, too.

The kicker piece should be neatly riveted to the choke lever and the rivet should

have a shoulder so the two parts remain free on riveting. On this example, the choke lever does not move freely on the kicker. There is only one washer on that rivet where there should be two – a plain and a wave washer.

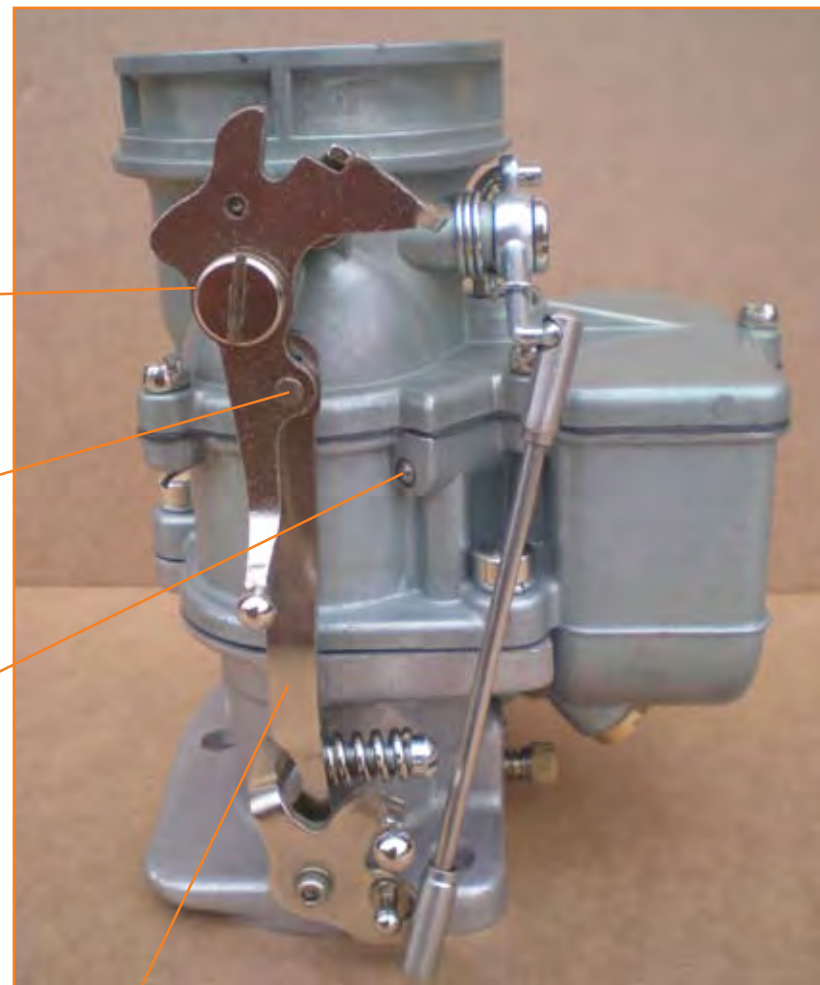
The idle and power valve circuits are plugged with what look like ball bearings. They should be lead plugs, though the Genuine Stromberg 97 uses tin for environmental reasons.

The throttle/choke kicker bar not even a close reproduction. It has the wrong shape and no patent mark stamped on it. The throttle adjustment spring and screw are mounted wrongly. The screw has an incorrect head shape.

None of these parts are stainless steel like the original Stromberg pieces.

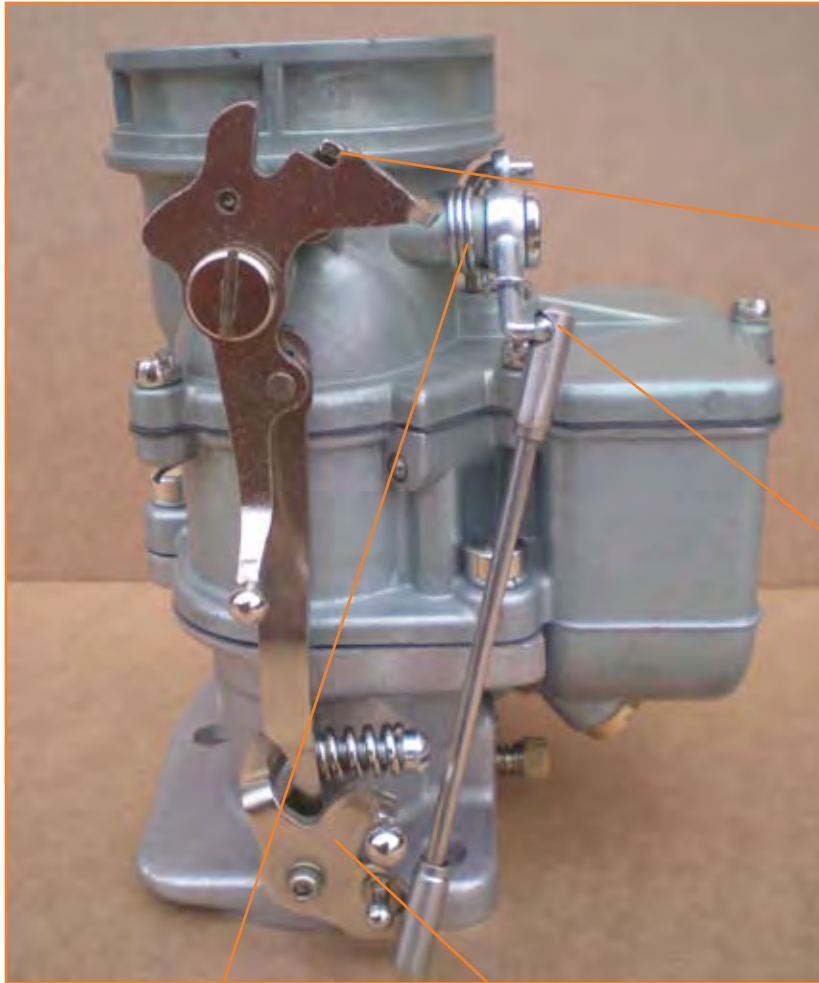
The Speedway choke shaft end lever is not stainless steel and it is fixed with a screw. It should be riveted like the original Stromberg part (see right). The choke return spring was pulled out of shape.

The choke lever detent pin is plated steel, not stainless steel. The spring (hidden under the pin) was fixed on the wrong way around.

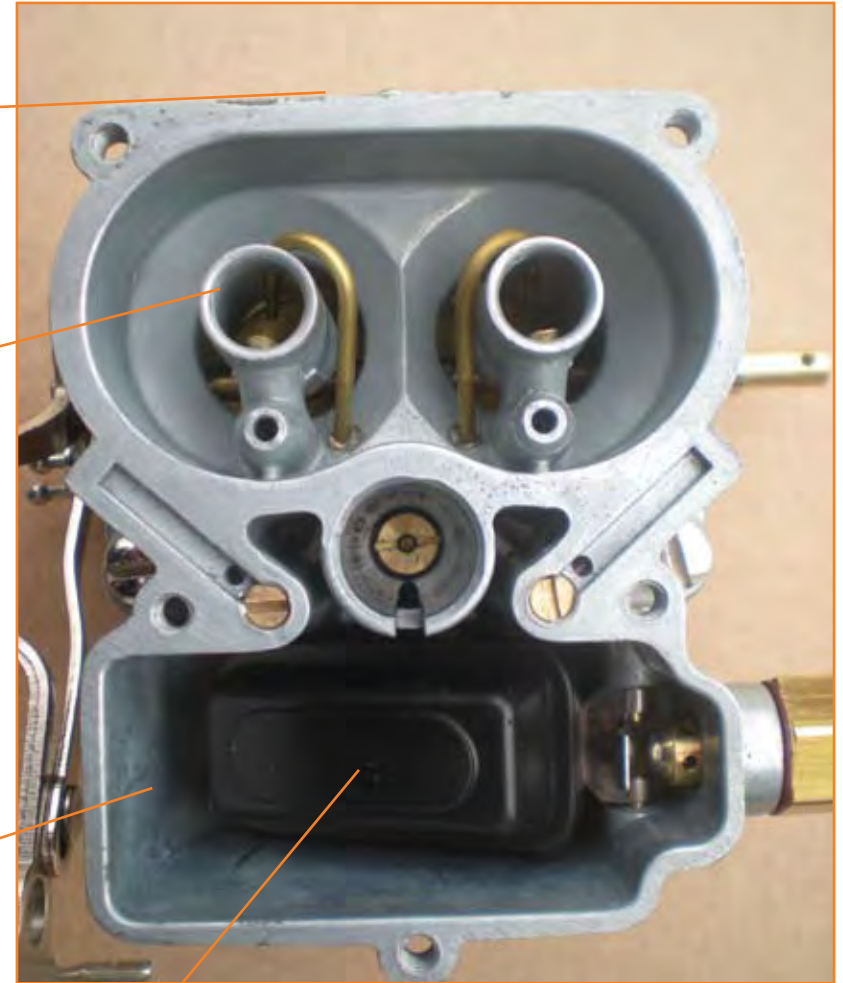
The accelerator pump well looks like it was chamfered at the top edge with a pen knife. And it is scored inside on what should be an exact reamed size.

The power valve pin was broken off and lying in the bottom of the accelerator pump well, meaning no power valve enrichment at higher revs. We have had the same report from another buyer.

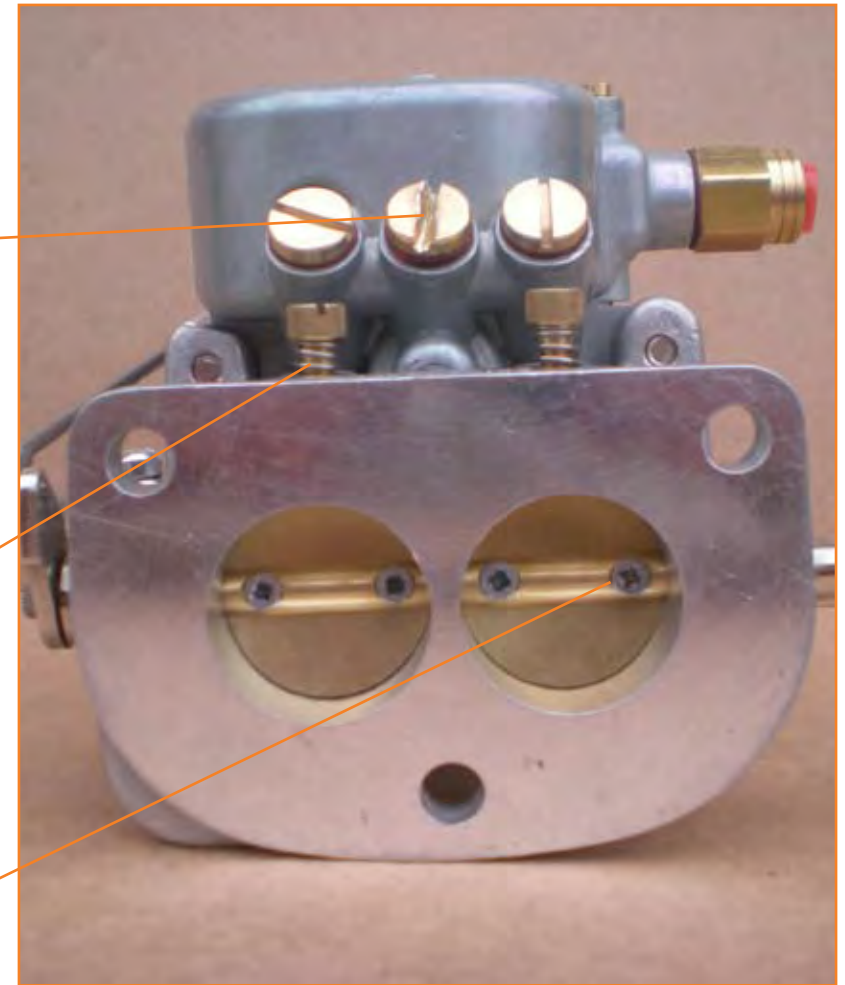
The throttle plate screws are not correct. They should be brass countersunk slotted. These are lightweight aluminium cross-heads with a very fine thread. And they don't have the hollow ends

so you cannot stake the ends to prevent them falling out. These examples look like they were sealed in with a liquid sealant. All this makes future service very difficult indeed.

The throttle plates are oversize. The original Stromberg specification is 1.855inch + 0 and - 0.002. These are 1.203inch so they do not sit correctly in the throttle bore.
